# Inspection Report

**Property Address:**  
1544 Kaahumanu Street  
Honolulu HI 96744

<b>Date:</b> 1/2/2011	<b>Time:</b> 09:00 AM	<b>Report ID:</b> 2011-01-08-Murakami
<b>Property:</b> 1544 Kaahumanu Street Honolulu HI 96744	<b>Customer:</b> Ted Murakami	<b>Real Estate Professional:</b>

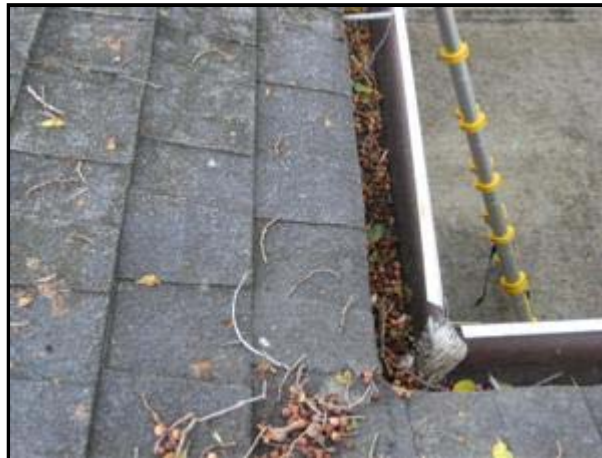
1.3 Picture 1

(1) The gutter needs cleaning of debris at the front of home, left side of home (facing front) and right side of home (facing front). Gutters that drain poorly or clogged can lead to many costly problems such as deterioration of fascia, soffit or roof edge. It can also cause gutters to pull loose and lead to possible water intrusion. A qualified person should repair or replace as needed.

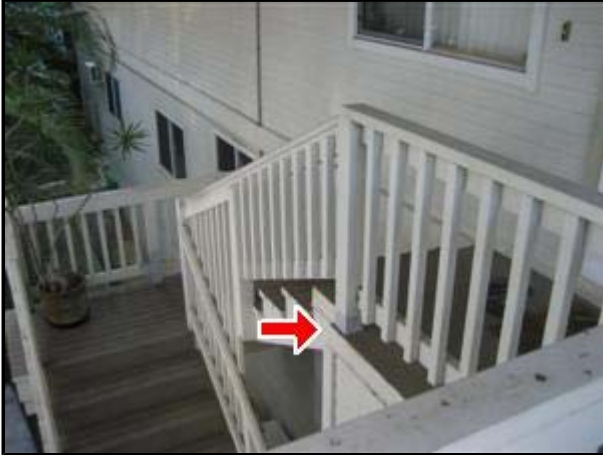
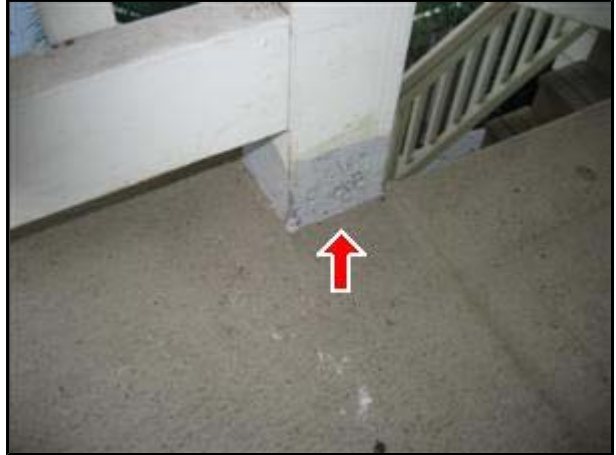
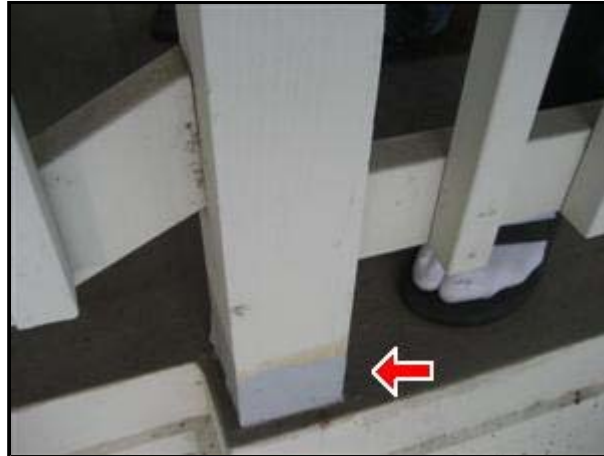
(1) The hand/guard rail post for the exterior stairs is weak and is not secure at top of stairs to upstairs deck. This is a safety issue. A repair or replacement is needed. A qualified licensed contractor should repair or replace as needed.

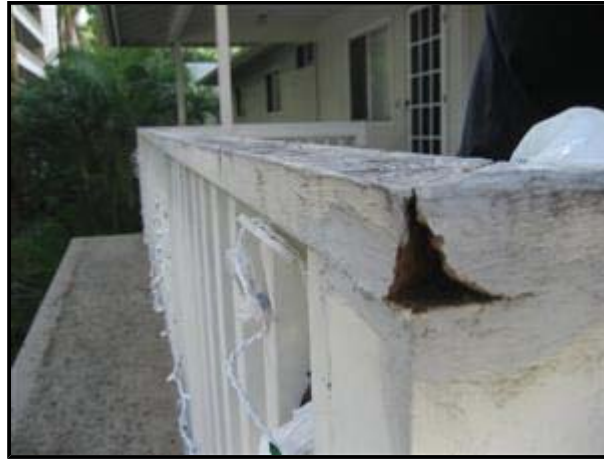
2.4 Picture 4

(2) The guard rail for the upstairs deck deteriorated at one area on left side of deck (see picture). A repair or replacement is needed. A qualified licensed contractor should repair or replace as needed.

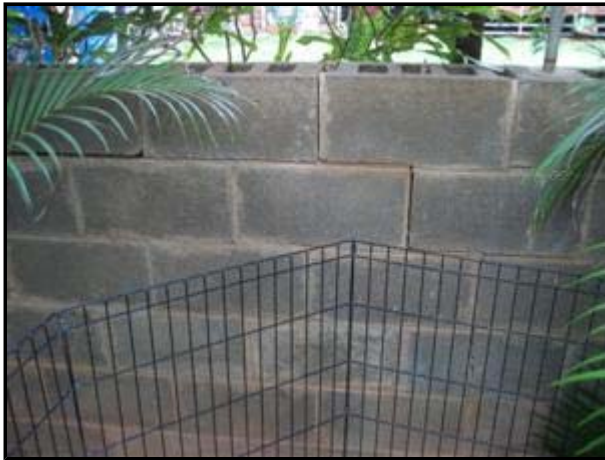
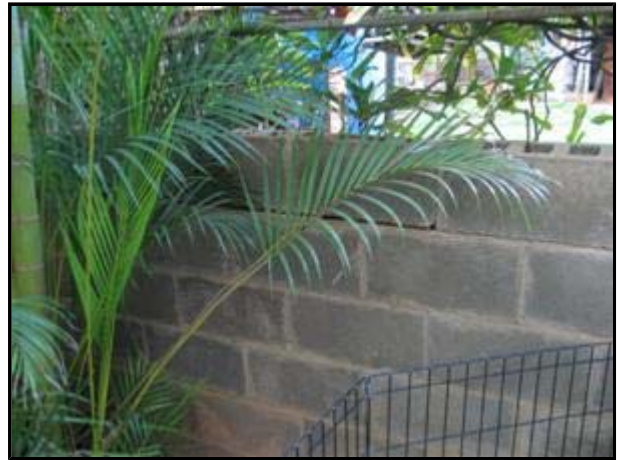
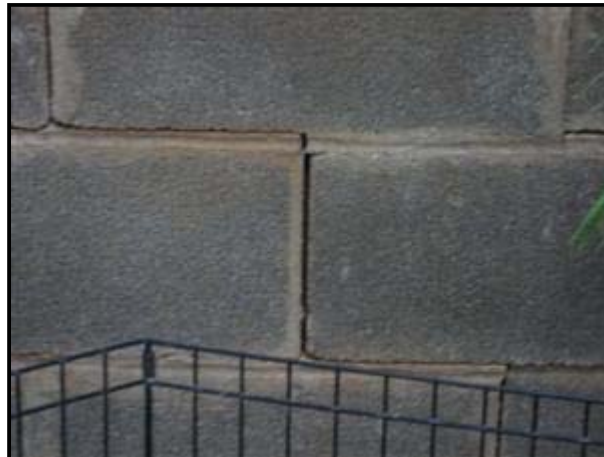
- 🏠 The retaining wall at right rear of home is leaning. It is not clear who owns this wall so this problem is not necessarily a defect of this property. This problem will continue to become worse and needs correcting. A licensed professional should evaluate and advise repairs.

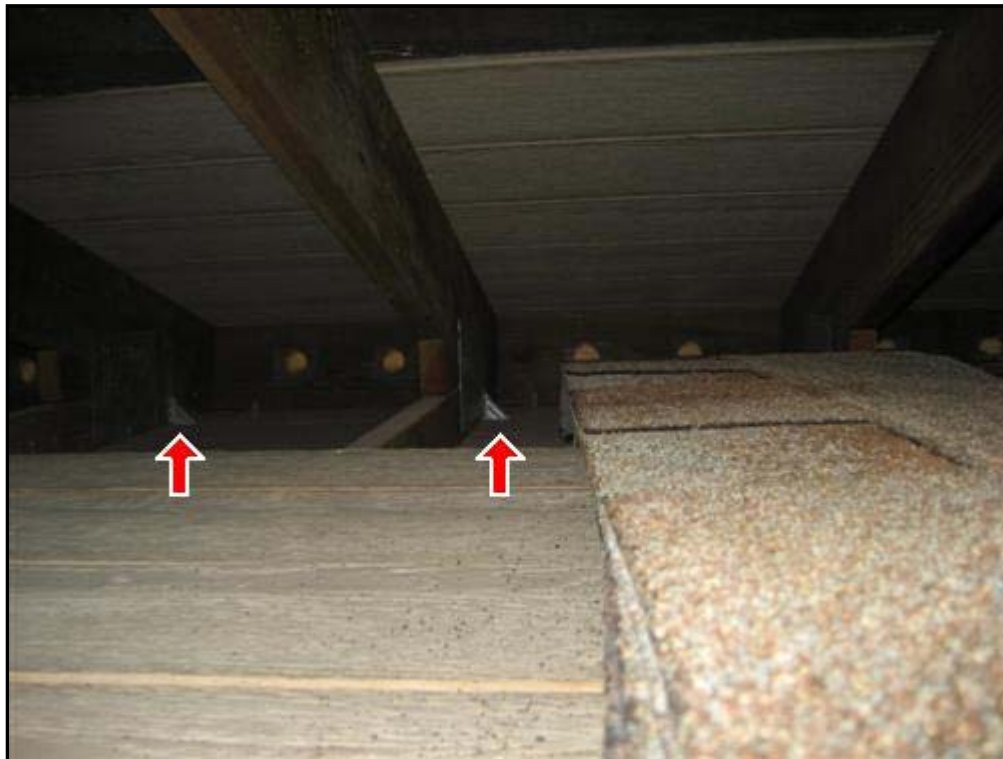
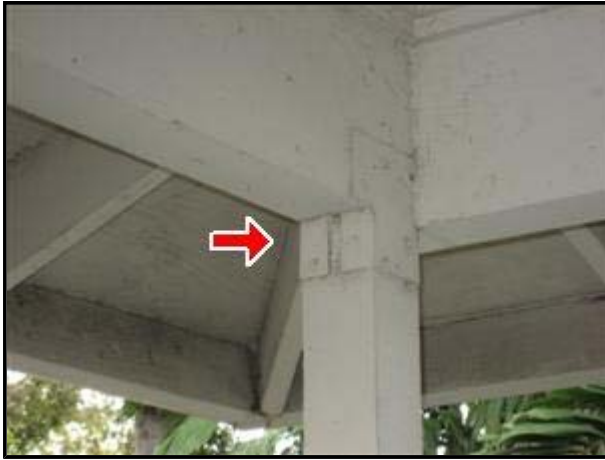
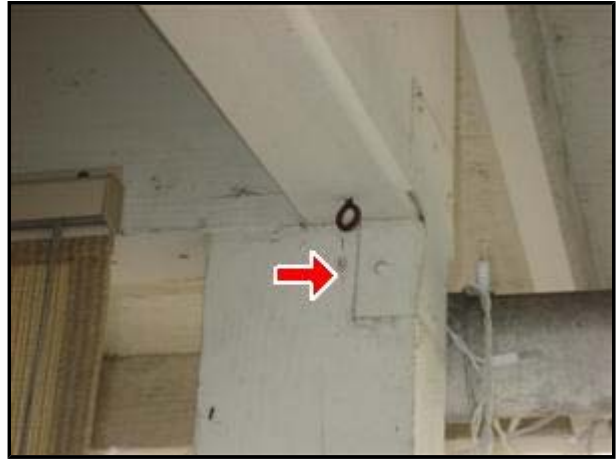
Hurricane clips/ties are visible but there are many concealed areas that cannot be verified. Inspector is not responsible to inspect concealed areas and cannot be held liable for missing hurricane clips/ties in these concealed areas. Hurricane clips/ties from roof to foundation are essential to prevent uplift in high wind situations. I recommend inspection and installation by a qualified and licensed professional.

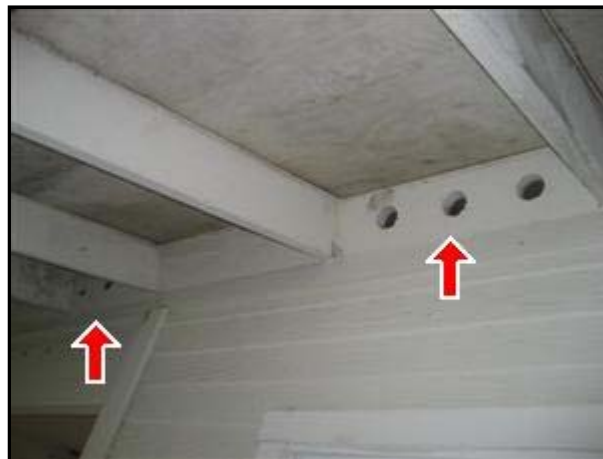
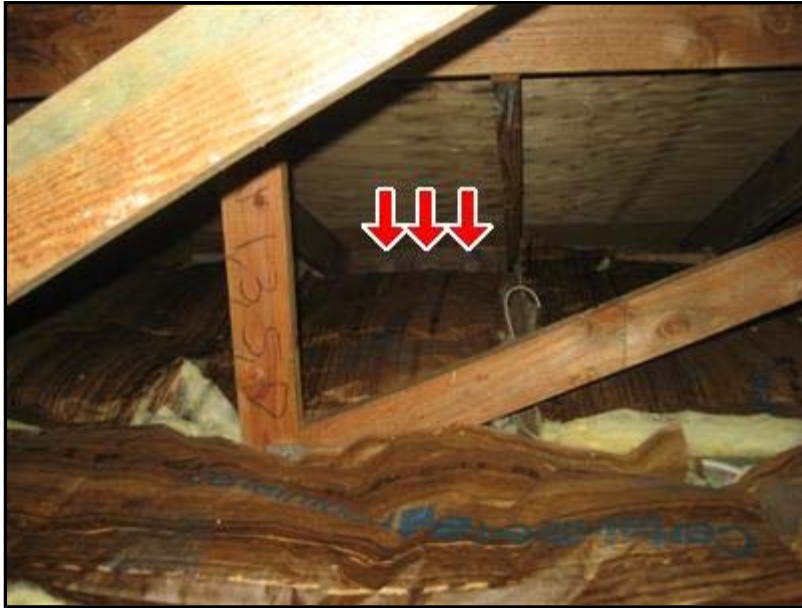
Soffit vents present every other rafter. I recommend increasing the ventilation with a ridge vent when roof covering is replaced. Evaluation and secondary recommendation by a licensed roofing contractor is advised.

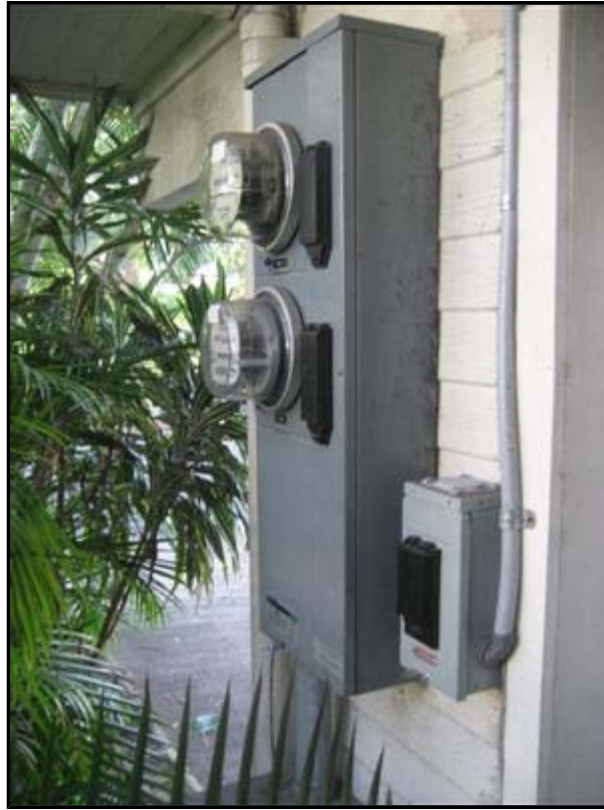
5.1 Picture 1

(1) The main panel box is located at the exterior right side of carport.

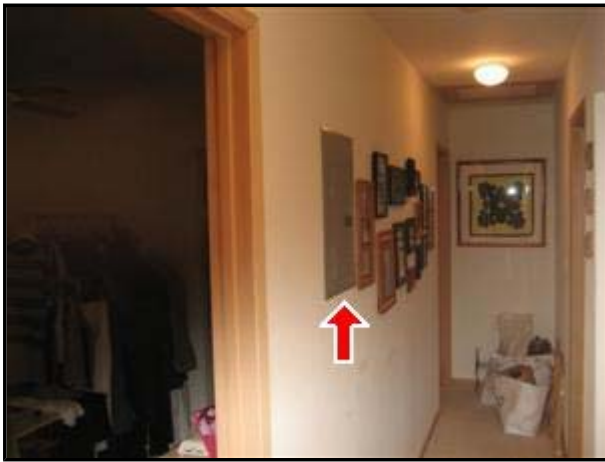
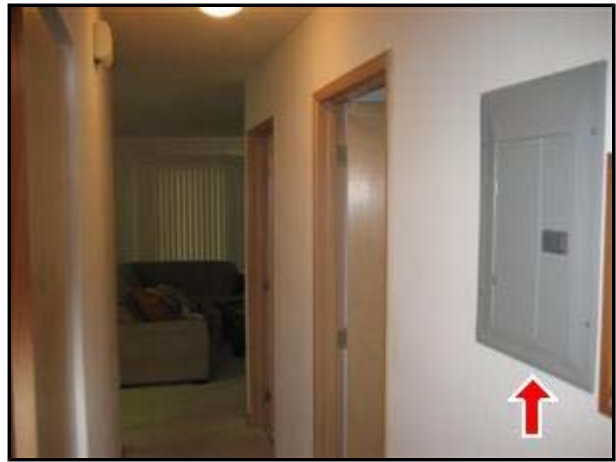
(2) The two distribution panels are located in the upstairs and downstairs hallways.

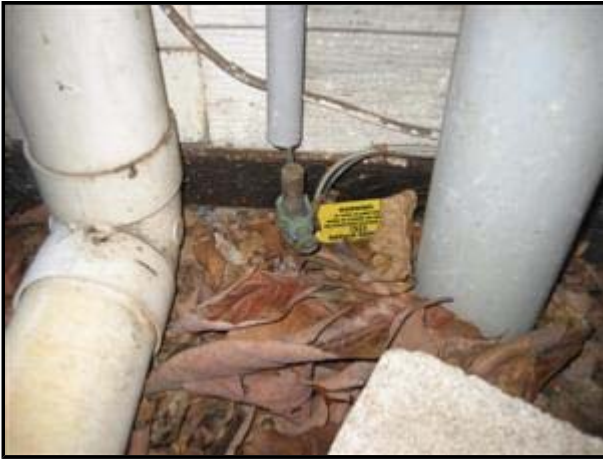
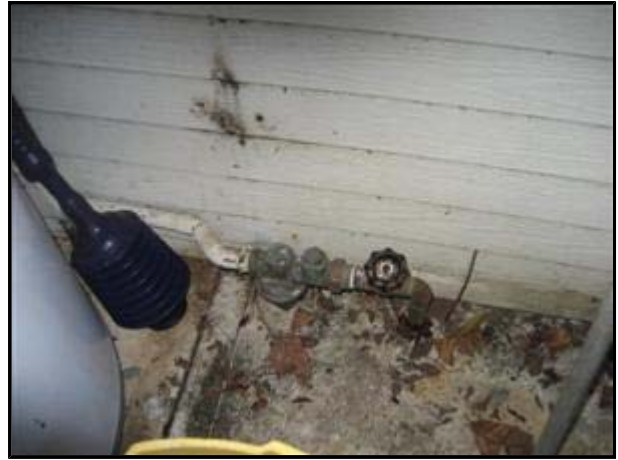
(1) A ground wire to ground rod is present at meter base and a ground wire is present on metal plumbing.

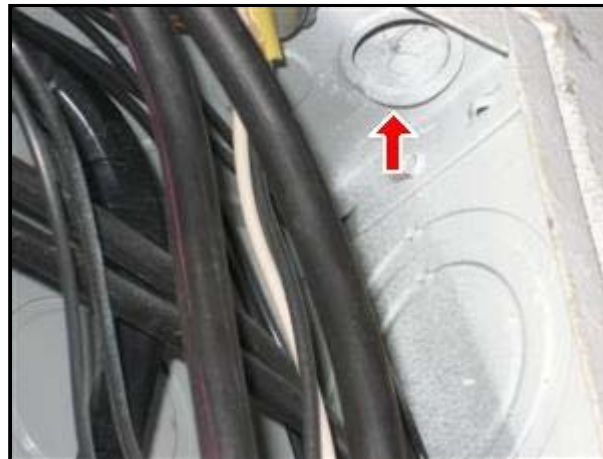
5.2 Picture 3

- 🏠 (2) There appears to be the following problem(s), knock-outs missing on panel, discovered with the branch circuits at the upstairs distribution panel. I recommend a licensed electrical contractor inspect further and correct as needed.

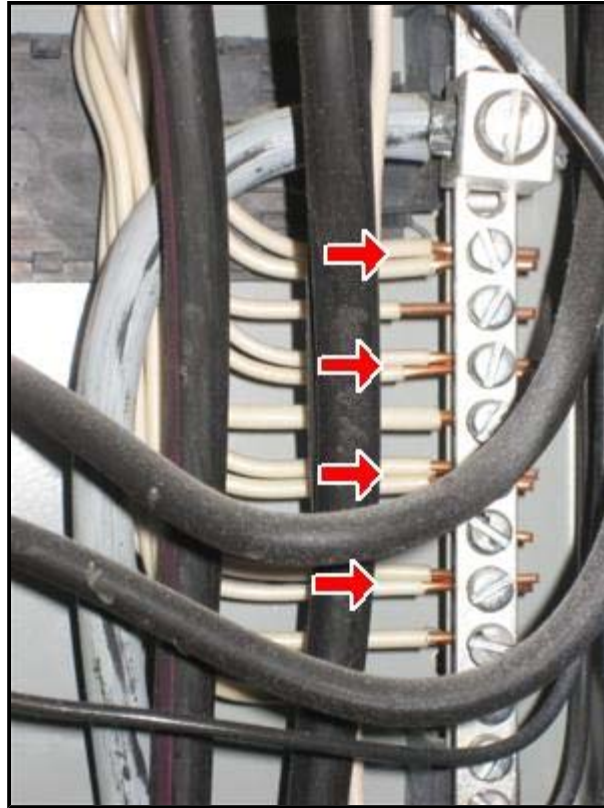
5.3 Picture 1

- 🏠 (1) There appears to be the following problem(s), doubled wiring at circuit(s), discovered with the branch circuits. There are multiple double taps of the grounded neutral wires at the upstairs and downstairs distribution panels. I recommend a licensed electrical contractor inspect further and correct as needed.

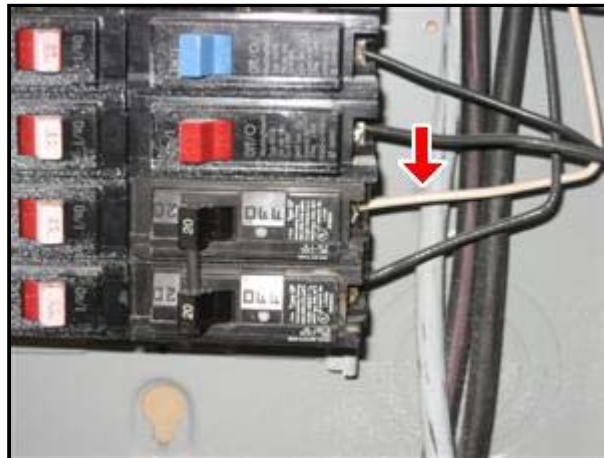
5.3 Picture 2

- 🏠 (2) There appears to be the following problem(s), the wrong color wire is used for a ungrounded (hot) connection, discovered with the branch circuits. A white wire is used but it should be a black or red wire or it needs to be marked with black tape to indicate an ungrounded wire. I recommend a licensed electrical contractor inspect further and correct as needed.

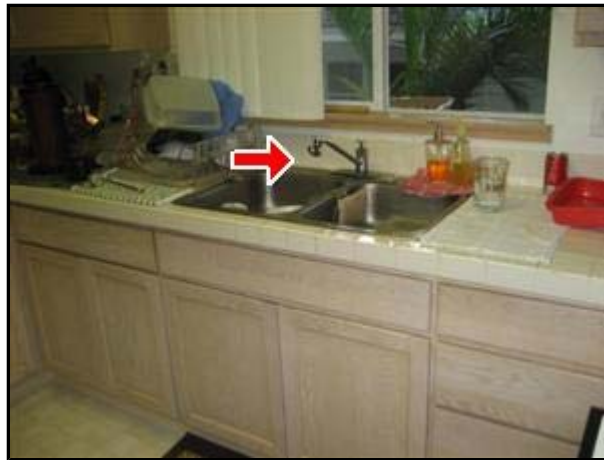
6.1 Picture 1

The faucet spout drips at the upstairs kitchen sink. Repairs are needed. A qualified licensed plumber should repair or correct as needed.

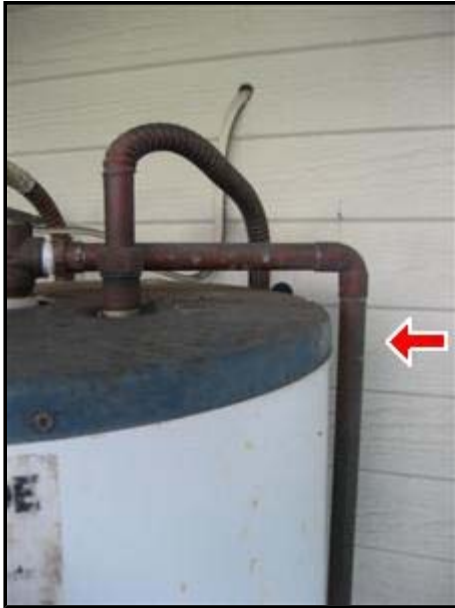
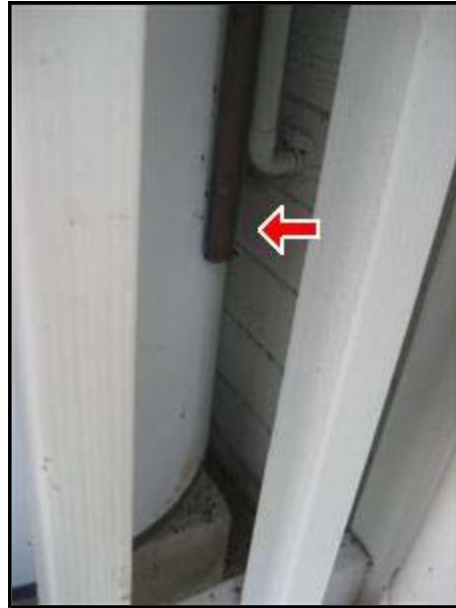
The existing piping for the temperature and pressure valve on upstairs water heater fails to extend downward to within six inches of floor. This can cause damage to the unit or shorten its life span. A qualified person should repair as necessary.

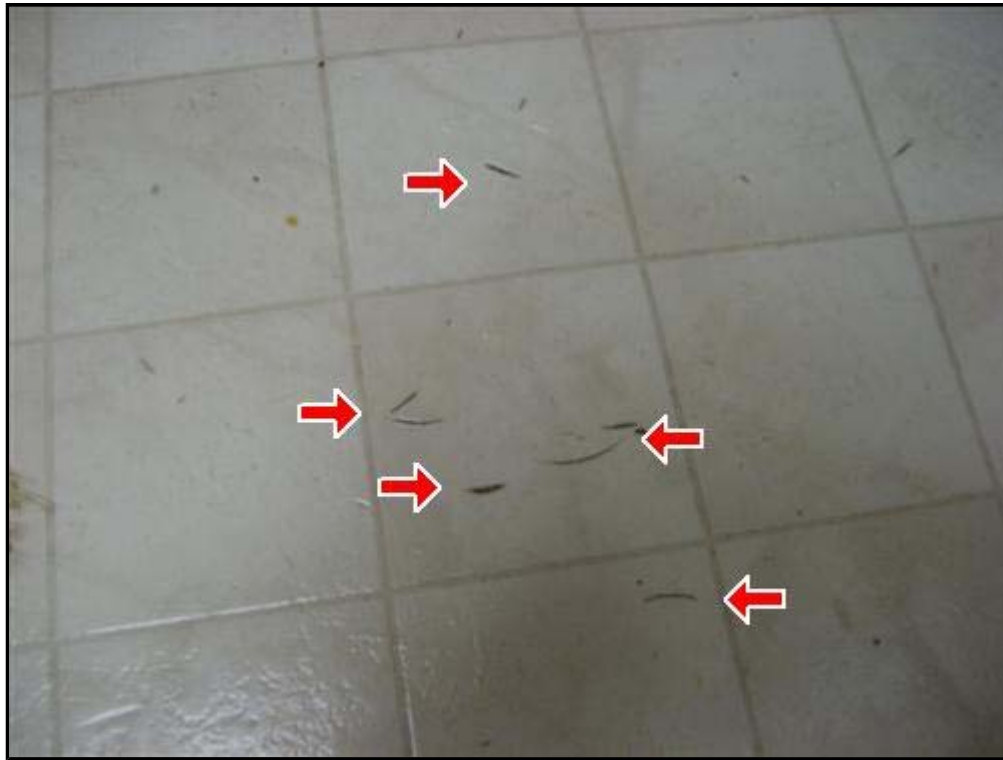
7.3 Picture 1

The vinyl flooring some blemishes or small tear at the ground floor. This is a cosmetic issue for your information. A qualified person should repair or replace as needed.

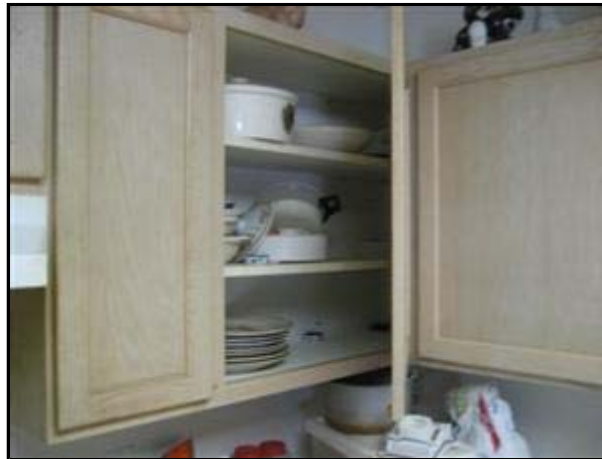
7.4 Picture 1

Some cabinet doors need magnets or hardware to stay shut at downstairs kitchen.

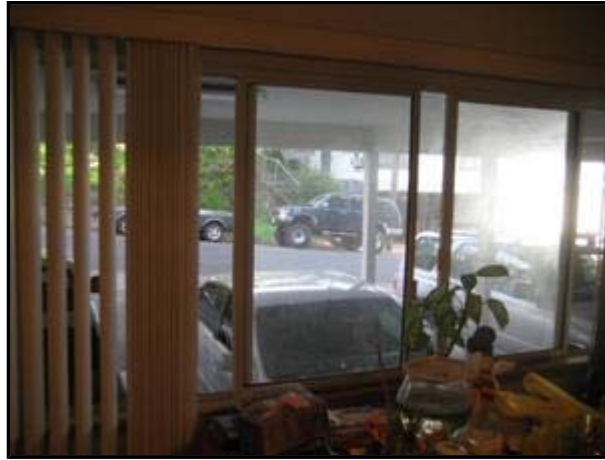
7.6 Picture 1

One sliding window is difficult to operate at the downstairs dining room. This is a maintenance issue and is for your information. A qualified person should repair or replace as needed.

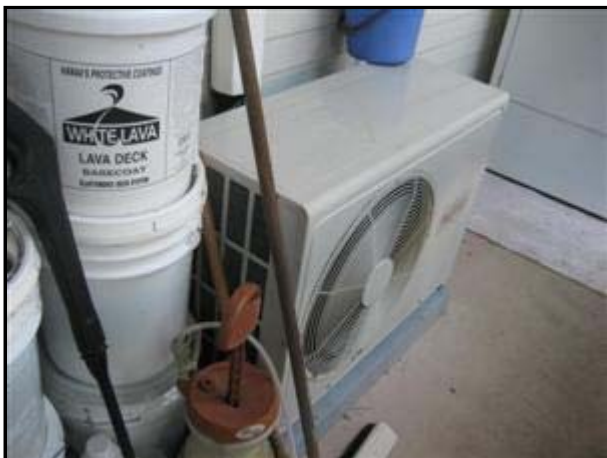
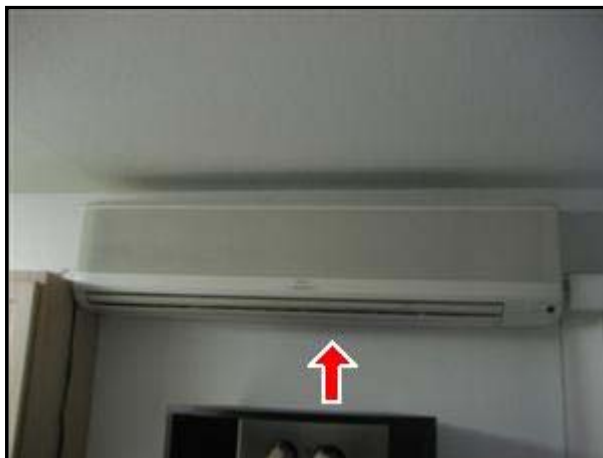
The split system AC unit in the upstairs living room is noisy and did not cool the air properly (needs to cool 14 to 22 degrees F). I recommend further evaluation by a licensed contractor and repair/replace as needed.

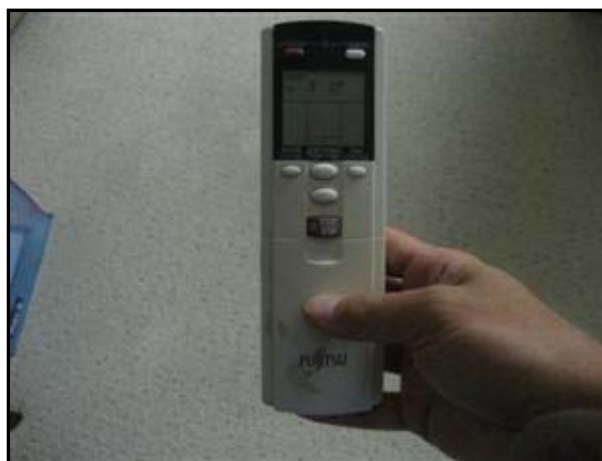
## 8.1 Picture 1

The upstairs split system ac control buttons are not functioning properly at times. I recommend repair or replace as needed.

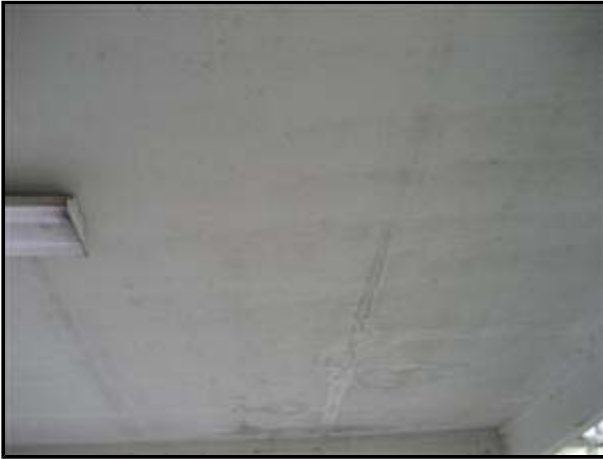
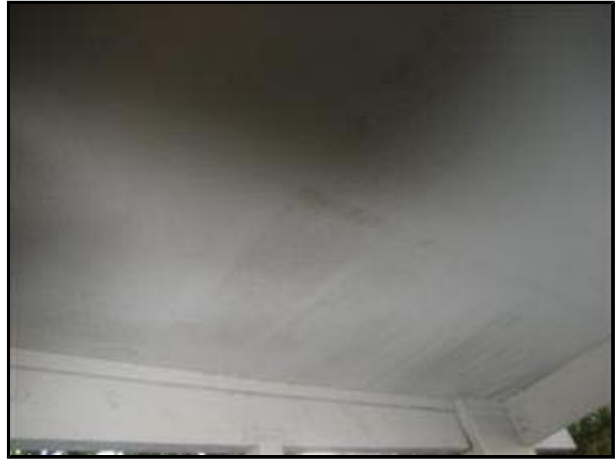
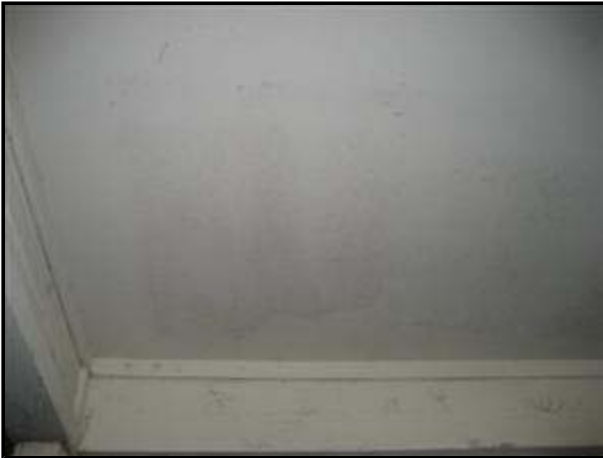
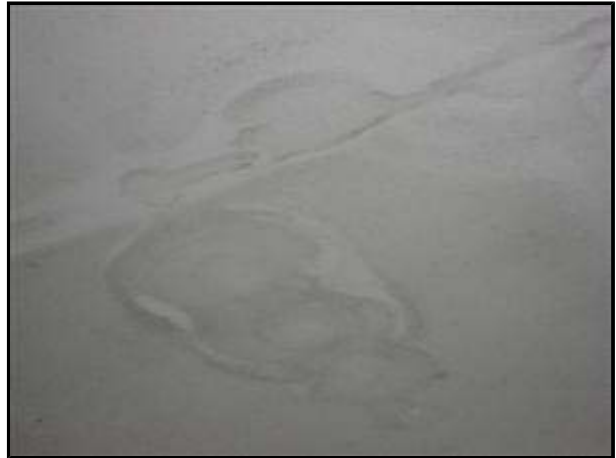
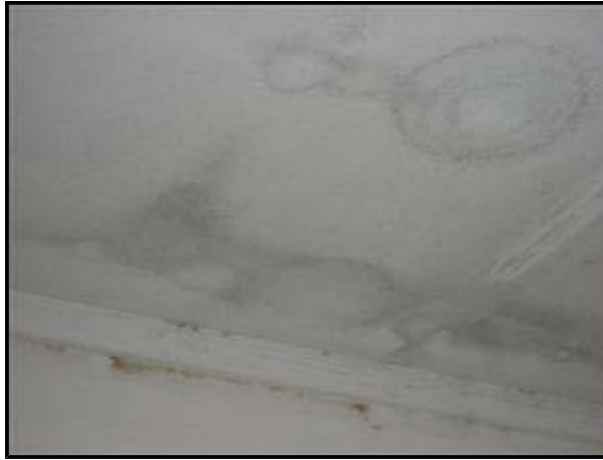
The drywall on the ceiling at the carport left and right side reveals a light stain which appears from a water leak. Stain appears old at the carport. The damage appears cosmetic but it could indicate a past or current leak and possible damage at hidden framing members. A qualified contractor should inspect and repair as needed.
